Manhole Inspection Summary

Manhole # S39A__026MH

Inspection ☐ Is Incomplete Rating: **3) Fair**

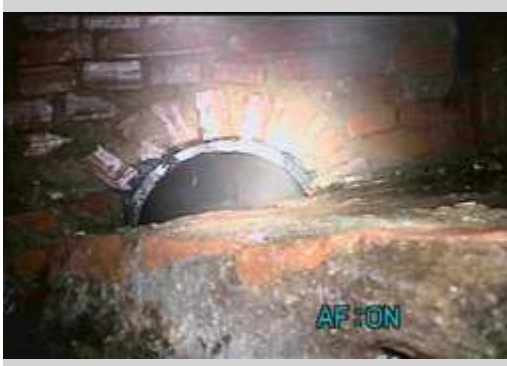
Misc

Additional view pipe in @ 8

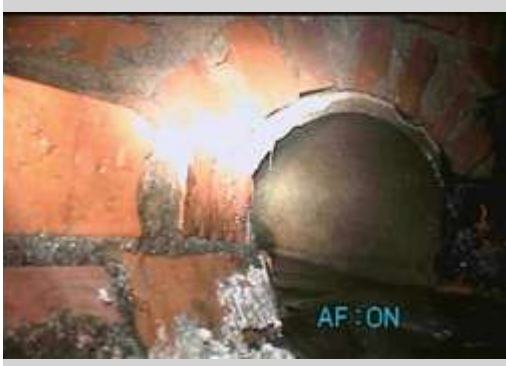
Misc

Additional view pipe out @12oclock

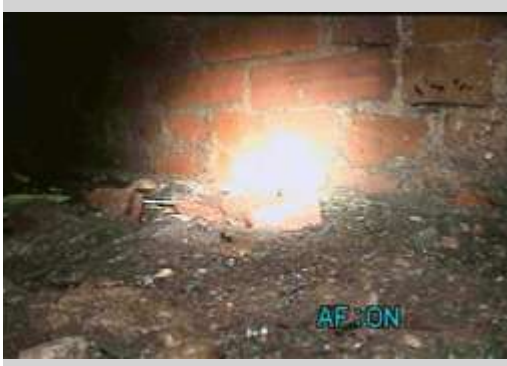
Defect 2

Condition: ☐ Sound ☐ Cracked ☐ Root Intrusion ☐ Deteriorated ☐ Leaks ☒ **Debris**

Bench Debris

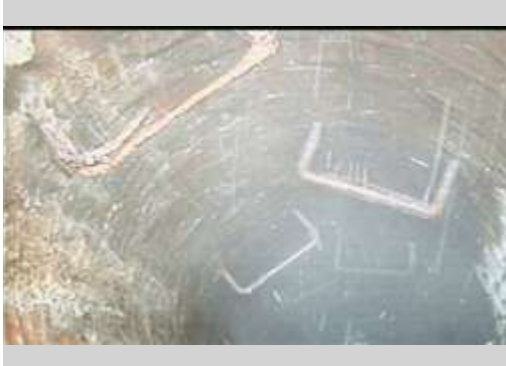
Defect 1

Count: **9** Missing: **0** ☒ **Corroded**

steps

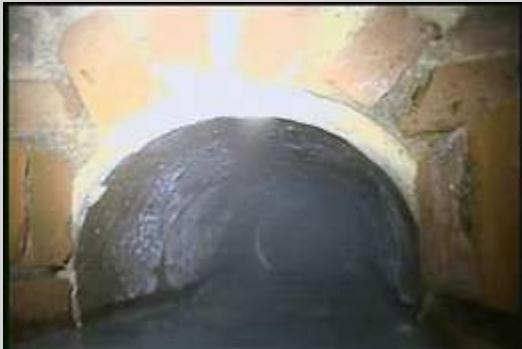
12 O'Clock Outflow

10 in. Circular Gravity Sewer
Pipe Out @ 12 O'Clock

Invert Depth: **13.65** (ft.) Flow Characteristics: **Slow**

Infiltration: **None** Pipe Seal Cond: **Unknown**

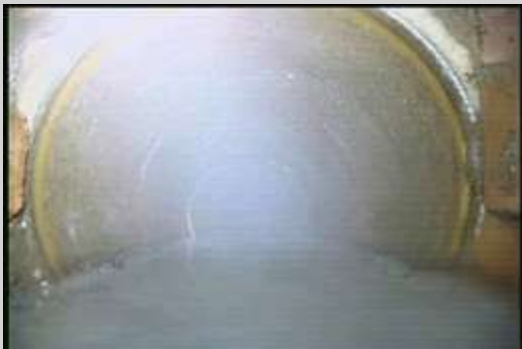
8 O'Clock Inflow

10 in. Circular Gravity Sewer
Pipe In @ 8 O'Clock

Invert Depth: **13.60** (ft.) Flow Characteristics: **Slow**

Infiltration: **None** Pipe Seal Cond: **Unknown**
